MAFBNZ Investigation of Compliance and Monitoring of the Scion GM Field Test.

11 February 2008

Report prepared by:
Kathryn Hurr
Operations, Border Standards Group
MAF Biosecurity New Zealand

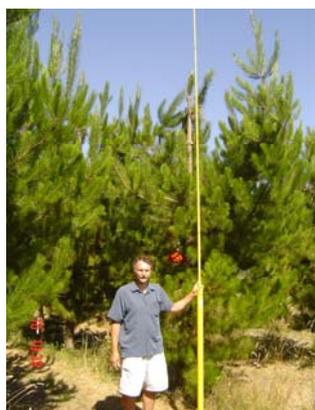
The height of all GM pine trees was verified on January 16 2008 as ranging between 4.5m and 4.8m, as measured against a fiberglass telescopic measuring pole. Topping is scheduled again within the next month to reduce the summer growth which the trees have put on since October.

Photo 1: The telescopic measuring pole used to measure the height of GM pine trees.

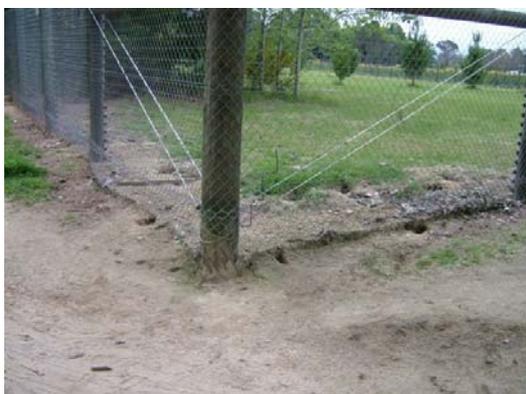
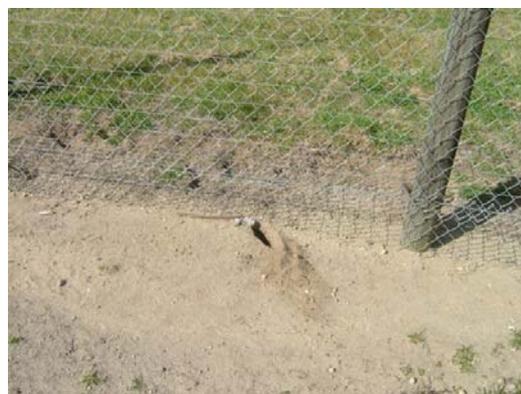
An inspection of the fence was undertaken to look for "holes in and under the fence". No holes were found in the fence, apart from the access point created by protestors in January, which was repaired immediately the Police had concluded their site investigation. There was no evidence of extensive, deep burrowing in the ground in front of, or inside the fence, which could compromise the security of the site. Photographs were supplied to MAFBNZ by Steffan Browning of Soil & Health, which showed deeper holes in the ground in front of the wire netting fence, reportedly taken in November 2007. These are not typical of the rabbit holes observed during the site investigation in January, or depicted in photographs 2 and 3 (also provided by Steffan Browning). MAF is still investigating the cause of these holes, and has not ruled out the possibility these were man-made for publicity purposes.

Many rabbit scratchings and shallow holes were evident around the fence perimeter (see photographs below), and within the field test site. These were estimated variously to be 5-15cm deep.

Photos 2, 3: Rabbit holes and scratchings, typical of those seen during the site investigation.
